Fritsch, Chiari & Partner ZT GmbH
www.fcp.at

Colle Isarco Viaduct – Structural assessment
based on periodic and permanent dynamic
monitoring

The investigation at the Colle Isarco Viaduct included three essential parts:

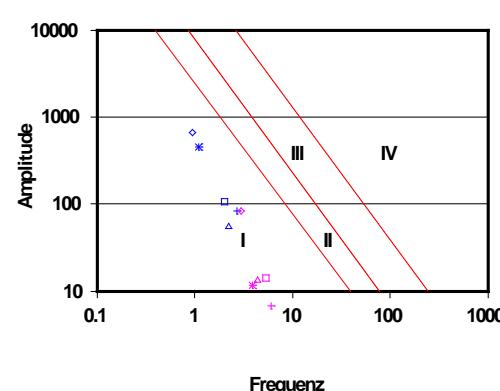
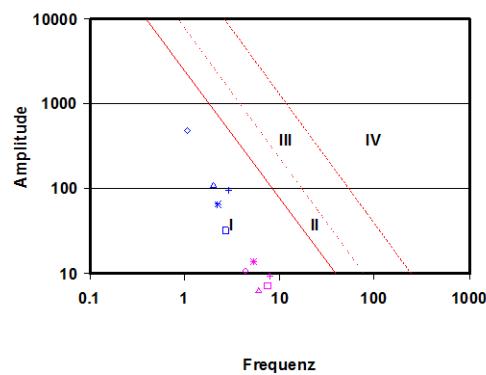
Vibration Intensity Analysis - Main structures

- Increased damping values are recorder. In 2007 in the CW South, in 2008 in the CW North.
- The vibration intensity analysis reveals values in the field II and III in the CW North and South respectively. Because of the fact that the traffic was restricted during the measurement this indicates a high dynamic sensitivity of the structure.

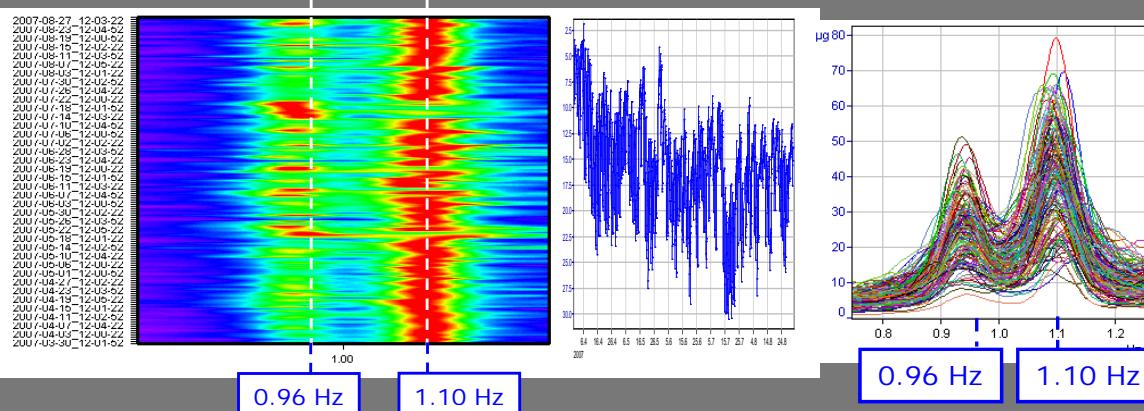
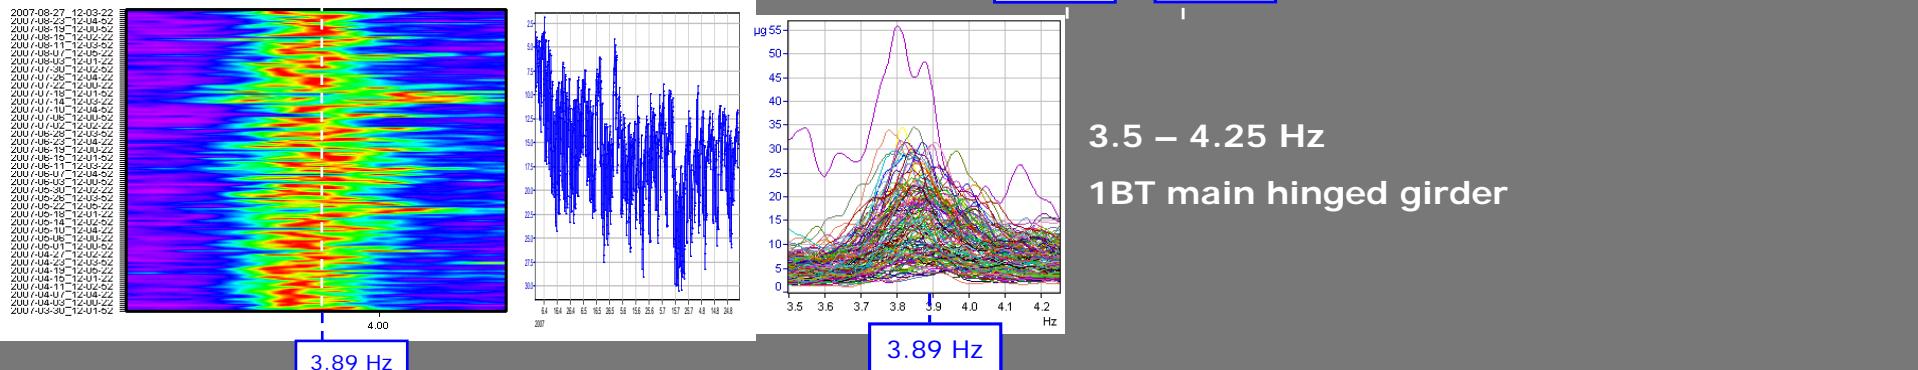
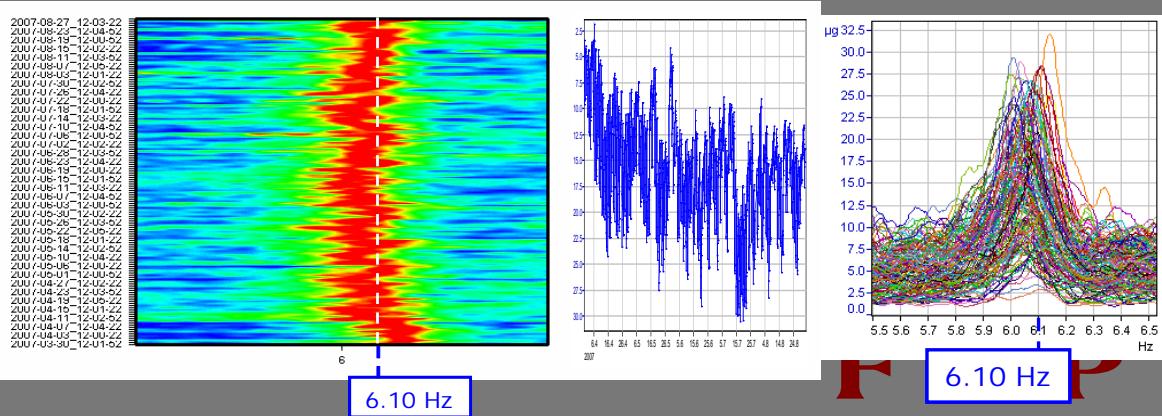
Frequency trend, spectra and temperature sequence over the whole measurement period in vertical direction (CW South)

- The area of the main hinged girder and cantilevers will demand special attention.
 - In the trend cards of the CW South the eigenfrequencies of the main hinged girder show a wide variance.

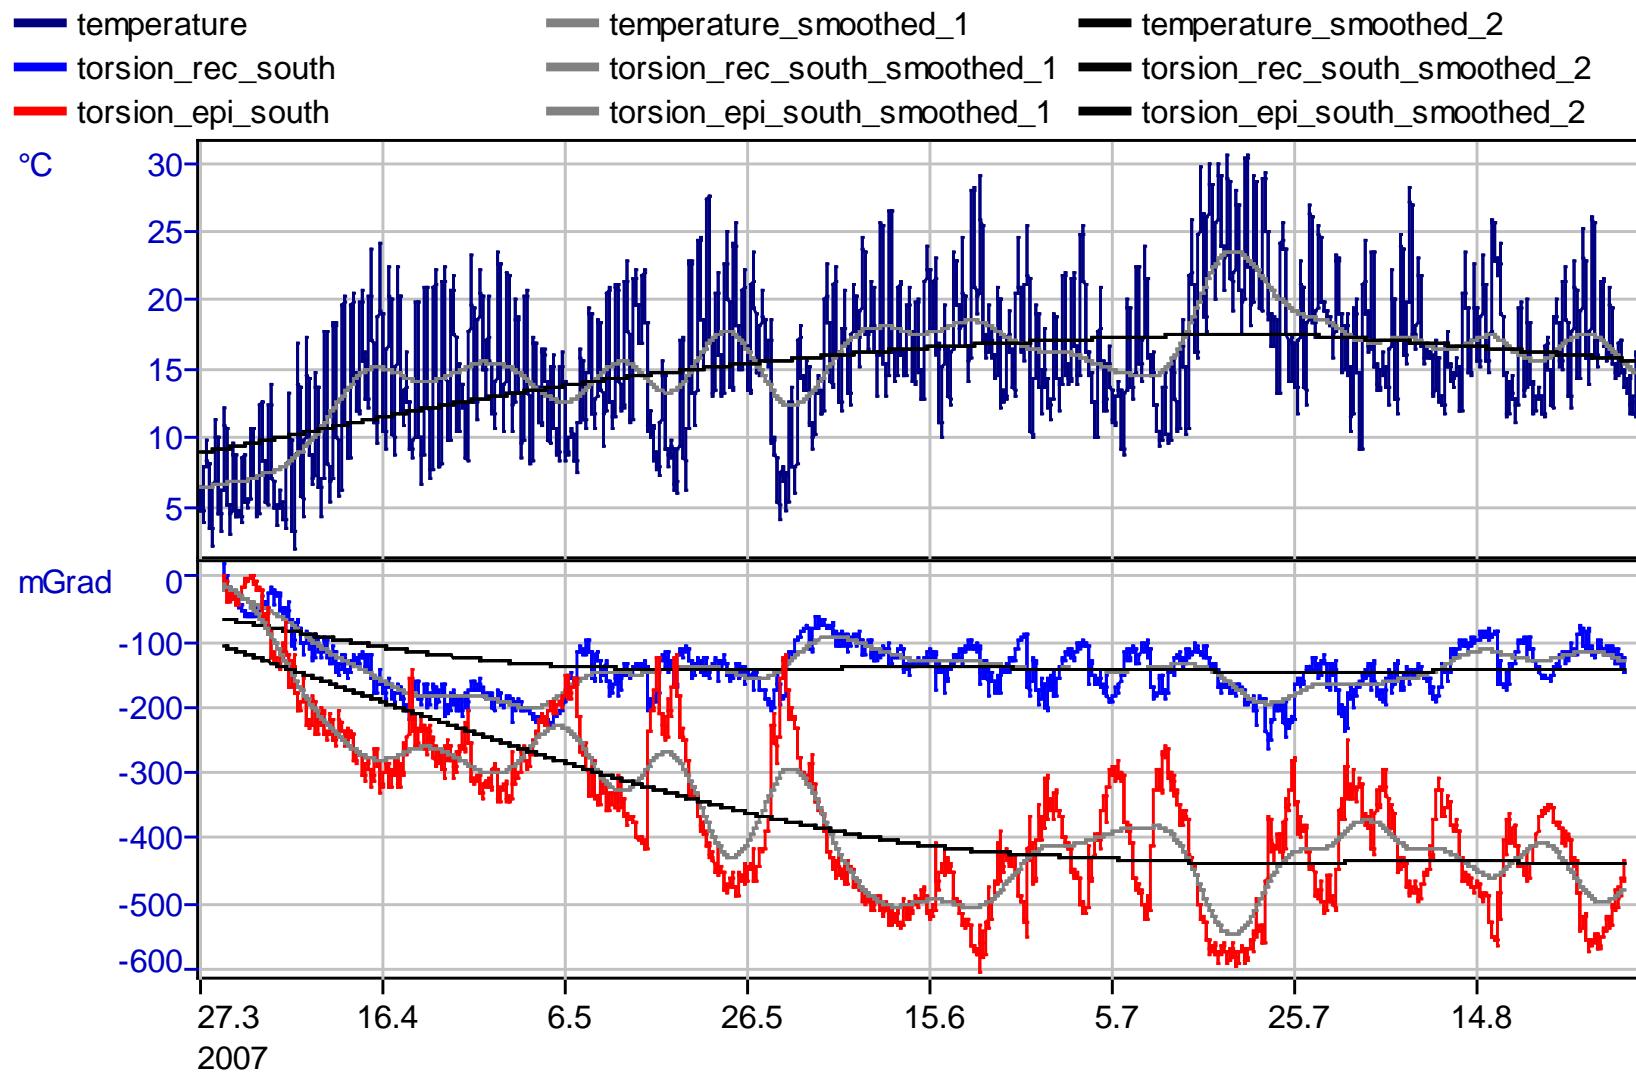
Trend of torsion – recorder (blue) and epi-sensor (red) –
versus trend of temperature (CW South)

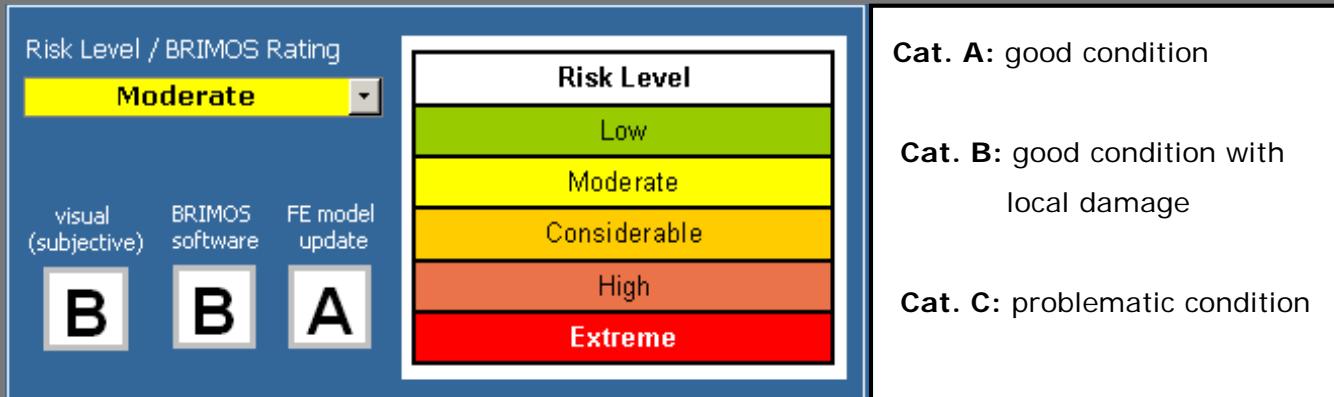
According to BRIMOS® classification the structure is rated as category B:
„structures in good condition with local damages“.

- Immediate actions: NONE
 - Short-term actions: NONE
 - Mid-term actions: NONE
 - Long-term actions:
changes in
every six
- Permanent monitoring with real-time data analysis
and automatic alarming in the case of
the behaviour
- Monitoring of the overall structural condition by
periodic measurements with BRIMOS®
years.

This approach assures the determination of slowly progressing processes in the structure leading to the deterioration of the operational integrity.
